Product Change Notification

Xtreme/10G Switch Firmware Update

PCN Number:	CTIU-00077
Revision:	0.00
Issue Date:	2024-02-21
Effective Date:	2024-02-21

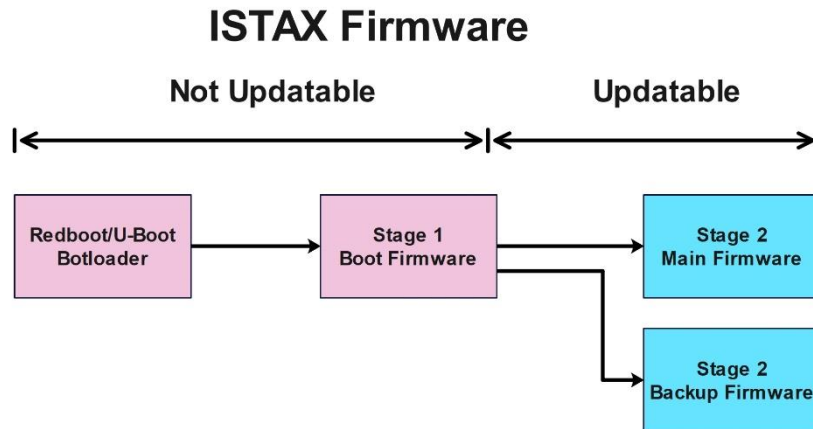
2.4 Checking Stage 1 Firmware Version

The Stage 1 firmware is independent of the Stage 2 (main) firmware and can be a different version.

The Stage 1 firmware version is not accessible from the Web GUI or serial console while the system is running. However, it is printed on the switches serial console on power up.

An example serial output showing the Stage 1 firmware version is “CTI XDG202 v2023-03.01.010” :
